Ligament Cracking of 2¼Cr-1Mo (SA-335 P22)

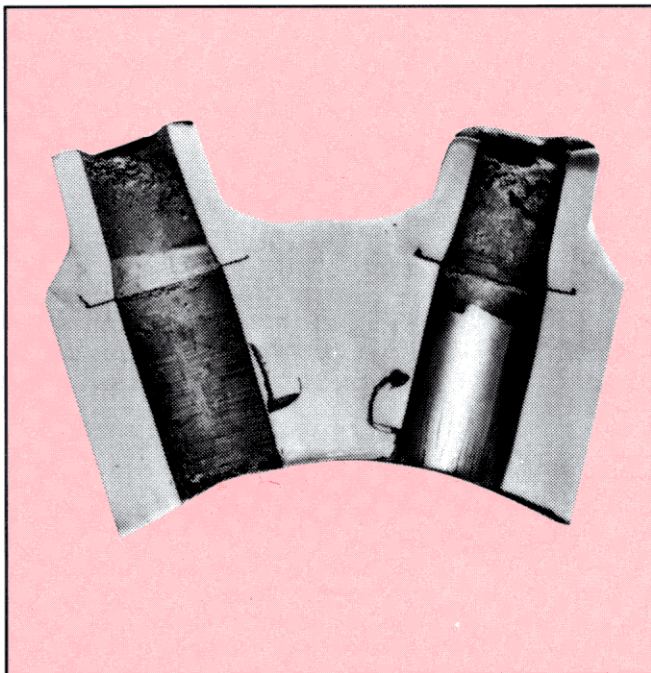
Recent inspections of 2¼Cr-1Mo(SA-335 P22) superheater outlet headers have revealed cracking in the ligaments between the tube bore holes. Although the cracking discovered is most severe in units operating at steam temperatures of 1050F or above, it may also occur on headers operating at lower temperatures (above 975F) for longer time periods (20 years). The cracking originates on the inner surfaces of the header and eventually propagates through the wall.

Pressure and thermal stresses combine to cause maximum stress levels at the tube bore ligament area. Particularly damaging are those stresses associated with boiler load changes, and/or start-up cycles, or other sources of temperature fluctuation.

Note cracking on the inner surfaces.

These stresses may initiate and propagate cracks due to either fatigue, or a combination of creep and fatigue.

All units having 2¼ Cr-1Mo superheater and reheater outlet headers operating for 15 years or longer should be inspected. Those units operating at steam temperatures of 1050F or above should be inspected first, with other units at lower operating temperatures having a lower priority for scheduling inspections.

Header inspections should be performed to evaluate the extent of possible cracking. These inspections should include the following examinations:

Internal inspection should be conducted to evaluate damage. Investigations to date have shown that extensive cracks may be present on the inner surface of the header even though external examinations may not reveal any damage or appreciable swelling. Selected tube stubs from the highest stressed areas should be cut to provide access to the header. The bore of the tube holes and inside surface of the header should be cleaned of the internal oxide scale and inspected using special fiber optics. A fluorescent dye-penetrant examination is recommended.
