Oil Lighters (Steam/Air Atomized)

To alert customers to potential oil lighter problems, identify their probable cause, and provide solutions for improving operation.

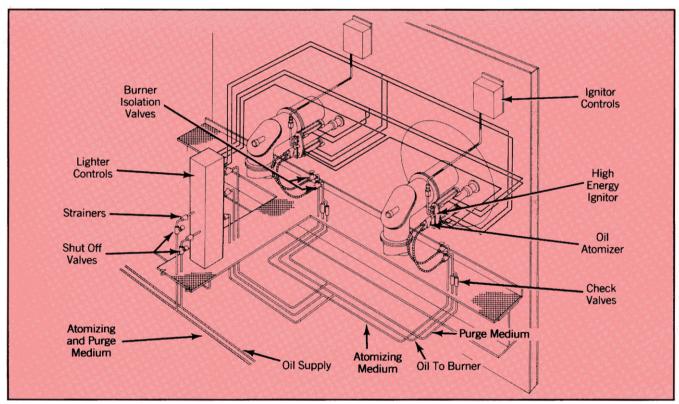
Figure 1 Typical lighter installation.

Symptom Atomizer tips plug. **Probable Cause** Contaminated oil.

- 1. Minimize or eliminate contamination by installing filters or strainers in the supply piping or at the lighter package inlet. (Figure 1 shows strainers installed.)
- 2. Upgrade existing Y or T jet atomizers to new I jet atomizers. The I jet atomizer (Figure 2) is less prone to pluggage.

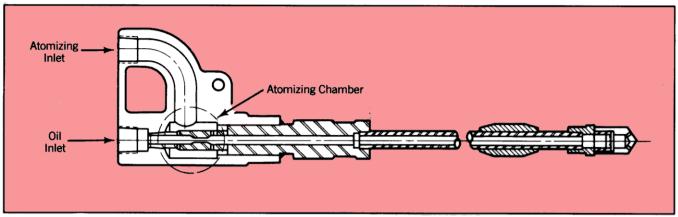
Figure 2 Typical I Jet assembly.

Symptom

Atomizer tips plug (cont'd).

Contaminated atomizing medium (steam/air).

Rust, scale or other foreign material in steam/air piping.

- Install properly located drains in the lighter steam/air piping. Use dryers in atomizing air system.
- Upgrade existing Y or T jet atomizers to I jet atomizers (Figure 2).
 Clean contaminated piping system.
 Suggested methods, similar to those used on initial startup, would include chemical cleaning and blow-
- Replace gasket between atomizer body and yoke. Figure 3 shows a Y jet atomizer. Other atomizers are similar.
- 2. Realign alignment pin.

- 2. Clean strainer in the atomizing medium supply line.
- 1. Reduce the lighter oil input to reduce opacity during cold startups.
- 2. Update to current standard reverse drilled sprayer plates.
- 3. Change the oil lighter to the CFS or MPO type to further lower opacity.
- 4. Upgrade existing Y or T jet atomizers to I jet atomizers (Figure 2).

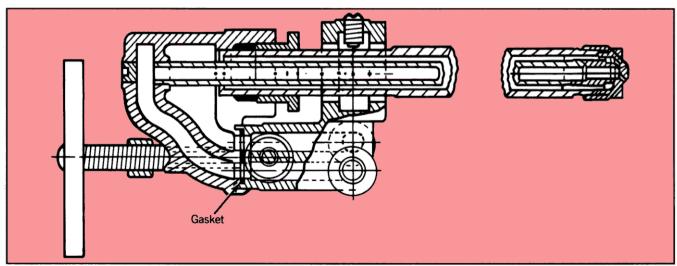
Figure 3 Typical Y Jet atomizer.

Faulty gasket installation.

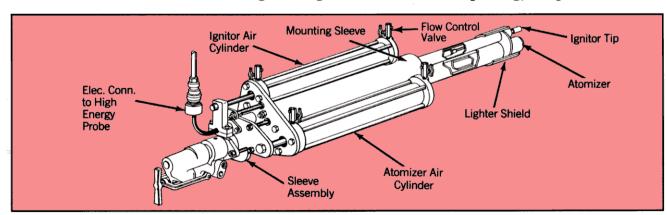
Figure 4 Oil fired lighter.

Oil lighter assembly does not insert or retract. (cont'd.)

Flow control valves excessively throttled.

Adjust flow control valves (Figure 4).

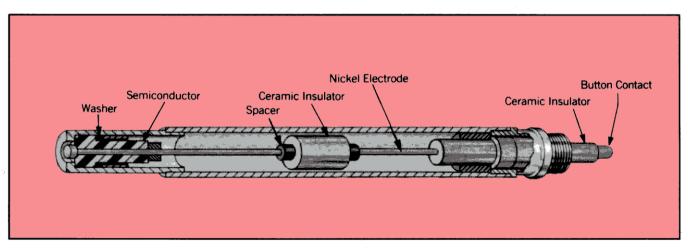
Figure 5 Spark tip.

Lighter spark does not ignite.

Spark tip burned out. High voltage wires grounded (Simmon's design).

Replace spark tip (see Figure 5).

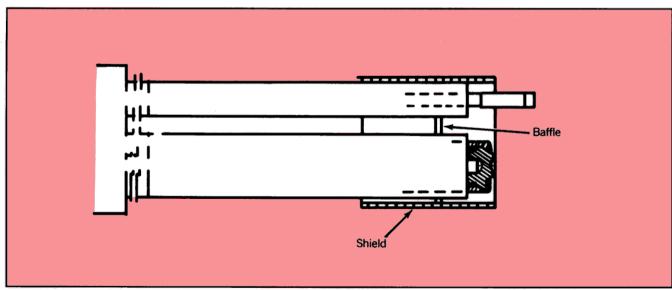
Figure 6 Typical cast CFA lighter shield.

CFA lighter flame shield oxidizes severely and deteriorates.

Material used for most existing lighter shields is plate, which has experienced excessive overheating problems. Replace with cast lighter shield to obtain longer service life (Figure 6).

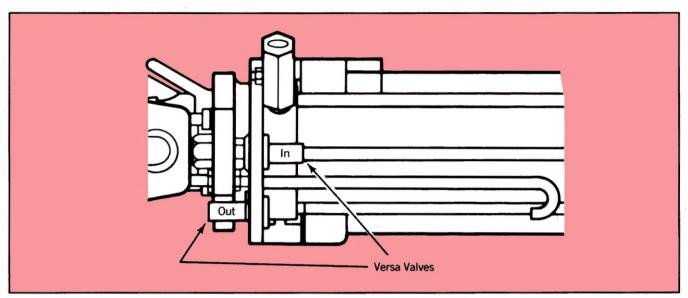
Figure 7 Versa Valves.

Versa valves do not function.

Valves are worn or actuating rod is improperly set.

- 1. Relace worn valves or adjust actuating rod to correct position (Figure 7).
- Replace worn Versa valves with proximity switches.
